PNNL-31459

# Resiliency of Polycrystalline Diamond Bearings Exposed to Marine Environments

6/30/21

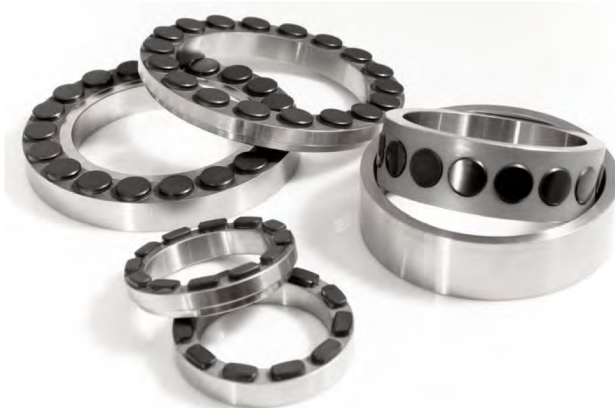
Figure 1. US Synthetic PCD bearings are available in thrust, radial and tapered (not shown) configurations

There are various types of bearings comprised of metals, ceramics, and composites that can be used in seawater. The most robust are polycrystalline diamond (PCD) bearings, a commercial newcomer. PCD bearings use sintered diamonds in a structured matrix that results in a durable bearing interface of diamond against diamond, with the two diamond facets layered on durable tungsten carbide shafts. The two diamond faces when first used have a brief period of higher friction while they self-polish smooth for a perfect mating (Knuteson, Sexton, and Cooley 2011). This self-polishing action makes these bearings forgiving in alignment as they will polish themselves smooth should alignment of the bearing change. Commercial offerings are available in many sizes and thrust, axial and tapered configurations that can be customized for a variety of generator topologies (1). PCD bearings have been used in the oil industry, where they are

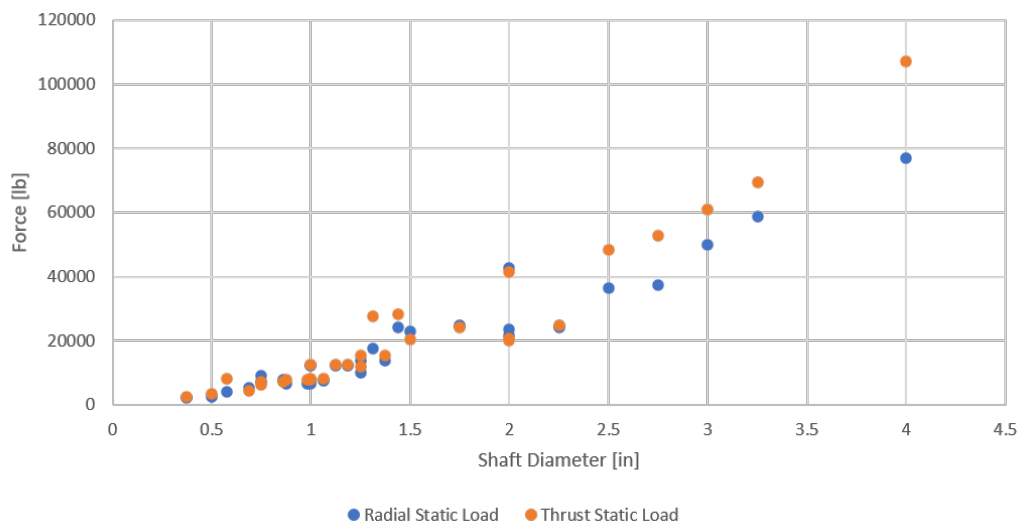
Figure 5. Tapered roller bearing maximum loads as listed on McMaster-Carr

the radial forces due to the pre- and side-loading. To determine the magnitude of the side-load, first, steel tapered-roller bearings' maximum static radial loads were compared to the same bearings' shaft diameters, shown in Figure 5. Knowing the approximate radial load of APL's 4"

bearing (F2 in Fig. 2) and the max load – shaft diameter relationship (Fig. 5), the approximate load to apply to the equivalent 1" bearing came out to 2.7 kN.

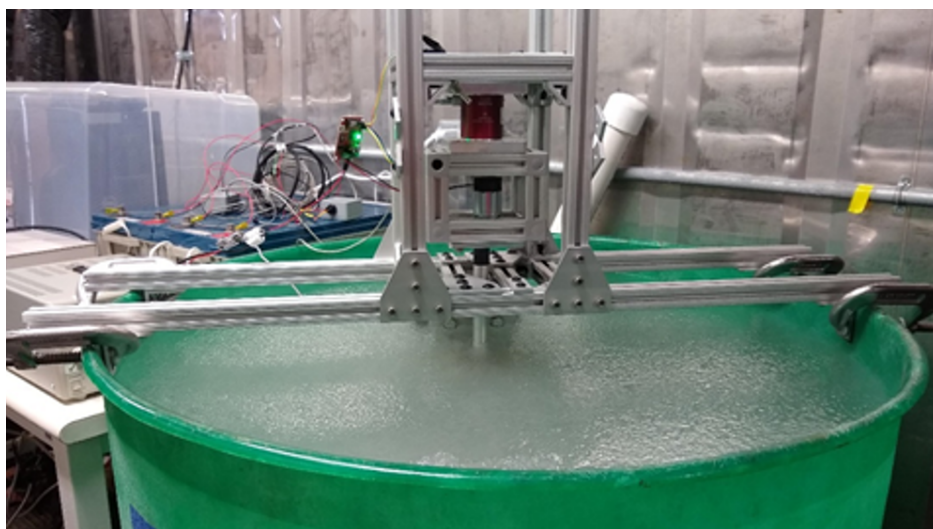
Figure 7. Bearing test stand in Arctic Laboratory with grease ice at surface

hours at 120 rpm rotation in unfiltered seawater at an average temperature of  $-2.4^{\circ}\text{C}$ , while logging bearing torque and side load. Steel and PCD bearings were weighed and photographed before installation into the bearing test stand. The test tank was filled until bearings were submerged under approximately 5 cm of seawater. A steel tapered-roller bearing served as a control during the first phase of testing, resulting in a baseline. Subsequent examination of a tapered PCD bearing was compared to the baseline to quantify wear as a function of exposure to raw seawater and freezing conditions, determine performance gains and make future recommendations. Temperature was logged from a TEWA TT0P-10KC3-T105-1500 Thermistor in series with a 0.1% precision 10k resistor being fed into a Landt CT3001D tester with a AT2016A auxiliary voltage monitoring system. The rails of the bearing test stand were attached to the sides of a 36" x 36" cylindrical fiberglass tank with c-clamps and 1/8" neoprene strips between the rails and tank to reduce vibration (Fig. 7).

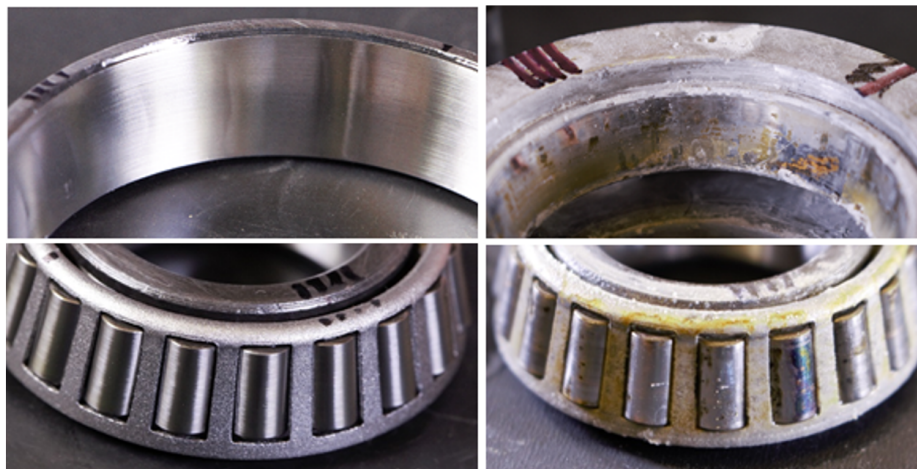
Figure 8. New steel tapered roller bearings (left) and after 1000 hours seawater exposure (right). Orientation is the same for both pictures

The steel control bearings showed significant signs of corrosion after 1,000 hours submerged. Multiple regions of iron oxide buildup indicate seawater was oxidizing the bearing inner and outer races as well as the rollers (Fig. 8). Instances of galling on the races are visible as vertical abrasions in the metal in a distinct repeating pattern of the same spacing as the tapered rollers themselves. This suggests that when the rollers abraded the surface, they followed a consistent pattern on the races and not at random across the surface. Side load did not stay constant over the course of the testing (Fig. 9). The side load constantly decreased around 5 lb/day until it suddenly dropped precipitously to zero 5 weeks into testing. The steel bearing's reaction torque remained constant until the side load dropped and torque increased exponentially, the reason for which is unknown. The steel bearings have a much higher CoF than published values, most likely due to immersion in raw seawater, ice formation, and lack of proper lubrication. They held up for 990 hours before failure. Examination of the bearings themselves showed corrosion products on the rollers and races, though the bearing could be made to spin freely with application of sufficient force. Regardless, the bearings would quickly seize up again after several low friction rotations.

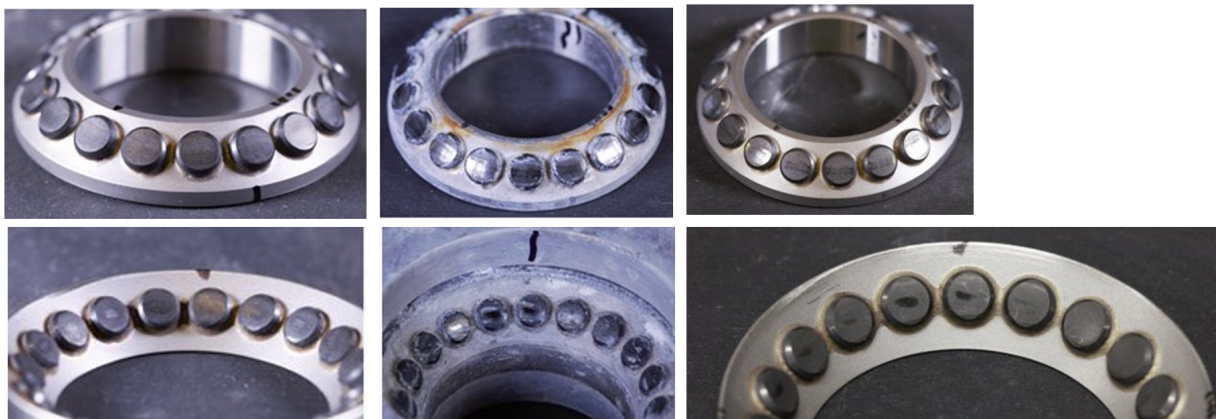
Figure 10. Inner race (top) and outer race (bottom) photographs. New PCD bearings (left), after running for 1,000 hours (middle), and after an acid wash (right). All pictures are taken from the same orientation.

The bearings on arrival were free of any observable defect such as hairline cracks or tarnishing (Fig. 10- left). The brazing used to adhere the PCD inserts into the duplex steel matrix did not show any inclusions or discontinuities. After testing, the bearing's inner race showed a ring of iron oxide from the iron retaining ring helping secure the race to the shaft, and while white aluminum corrosion covered the majority of the bearing surface, no corrosion of the brazing or steel matrix was evident (Fig. 10- middle). The aluminum corrosion from our test stand sloughing off and coating everything was likely aluminum oxide, the crystalline form of which is corundum, which has a Mohs hardness of 9. Aluminum oxide is used as a commercial abrasive as it will scratch virtually all other minerals except diamond. After acid washing, the bearings looked virtually identical to their pre-test state with the exception of the polished wear patterns where the bearing pads were in contact (Fig. 10- right).

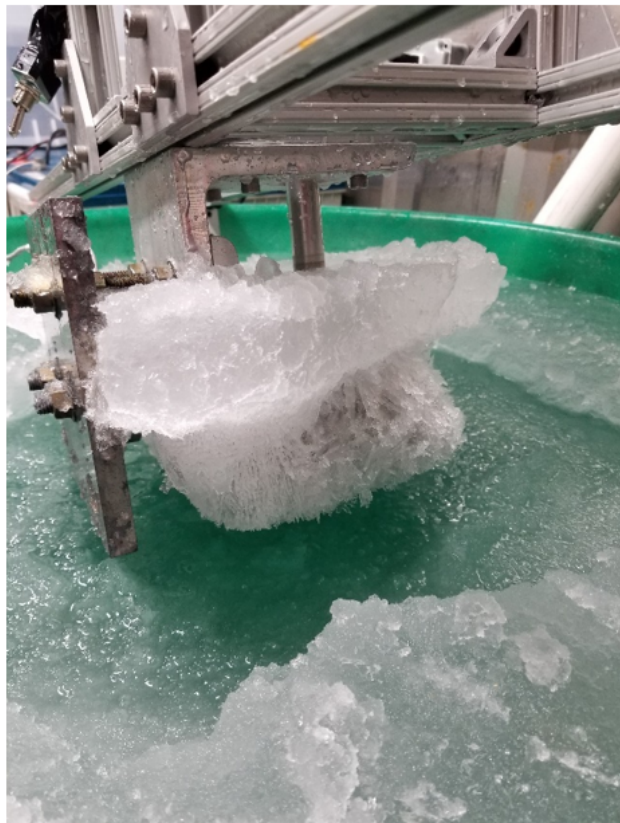
Figure 13. The PCD bearing after 450 hours of running with ice buildup in the bearing

Ambient conditions did not remain constant throughout the length of testing. Ice within the test tank underwent multiple freeze-thaw cycles as Arctic Lab temperatures changed due to power outages and external factors. Room-temperature seawater formed a frazil ice structure at the surface after the test began and continued to freeze until it reached a state of grease ice. When the temperature of the Arctic Lab was cycled (i.e. above and below freezing), grease ice made the transition into forming solid “ice pack”, which froze 5-6 in of the surface layer down to the level of the bearings (Fig. 13). The bearings rotated in all ice conditions freely, though ice slurry would build up around the shaft over time. These changes in temperature continually altered the ice state within the tank, which induced external stresses on the test stand and altered loads on the bearing. At the end of section 5, ice stress locked up the shaft and burned out the fuse. The ice in the tank then had to be melted to free the shaft and bearing before restarting the motor.
